RESEARCH MEMORANDUM

INVESTIGATION OF RIM CRACKING IN TURBINE

WHEELS WITH WELDED BLADES

NACA RM No. E6L17

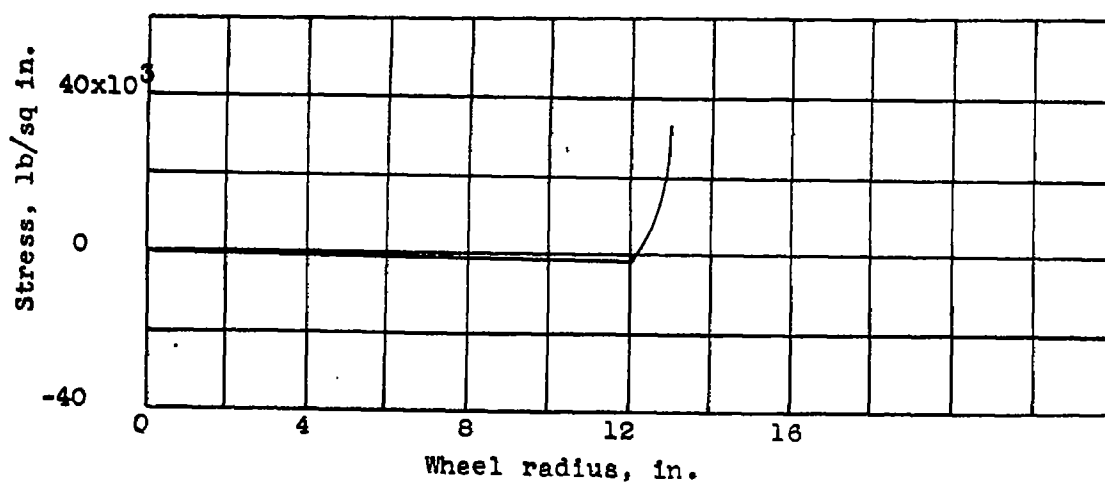
Figure 9. - Computed nominal tangential residual stress due to plastic flow at start in slotted composite disk.

the effective diameter of the wheel and the residual stresses that occur would hence be lower than in the unslotted disk. The elastic and plastic tangential-stress distributions that would be present in the slotted disk during the starting period are shown in figure 8. The resulting elastic tangential residual stress is presented in figure 9. The stress at the effective rim of the disk is lower than in the unslotted disk and has been removed from the junction of blade and weld metal, the region that is indicated as critical by British investigators, to the region containing a stress-relieved hole.
